Infrared Inspection

Pacific Crest Company

Site: Chicago Plant
821 – 33rd Avenue
Chicago, IL 60601

February 20, 2017

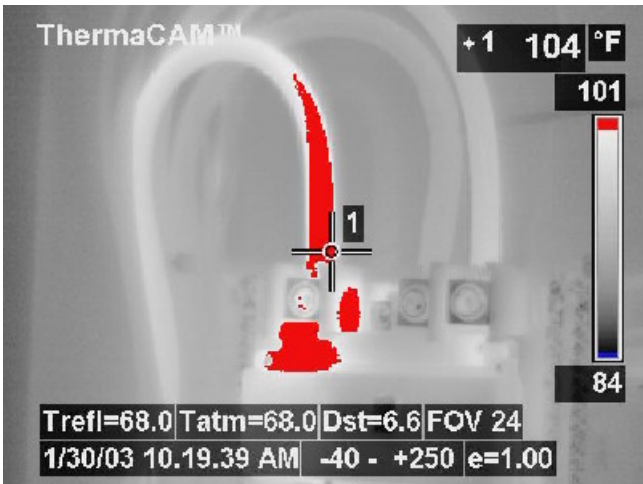
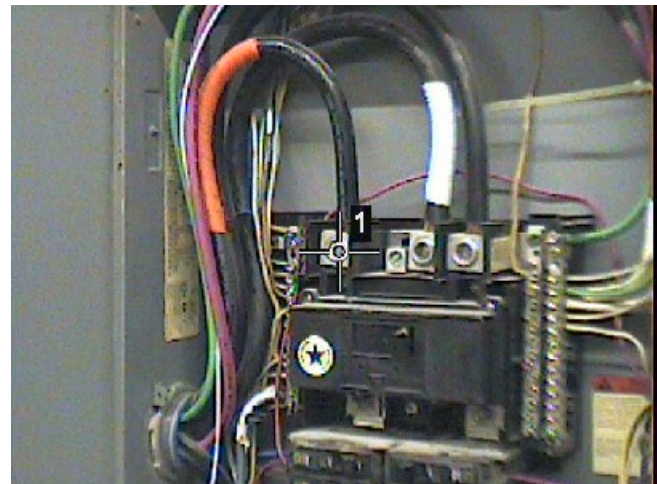
IR Image: IR_0036.jpg
 Photo: DC_0037.jpg

Asset ID: Barcode:
 Location: Main Building
 1 Floor
 Main Electrical Vault
 Main Switchboard

Problem	Reference	Temperature Difference	Ambient Temperature
A Phase: 165 F	C Phase: 110 F	55 F	78

A Phase line side wire lug connection on circuit breaker - 100 amp

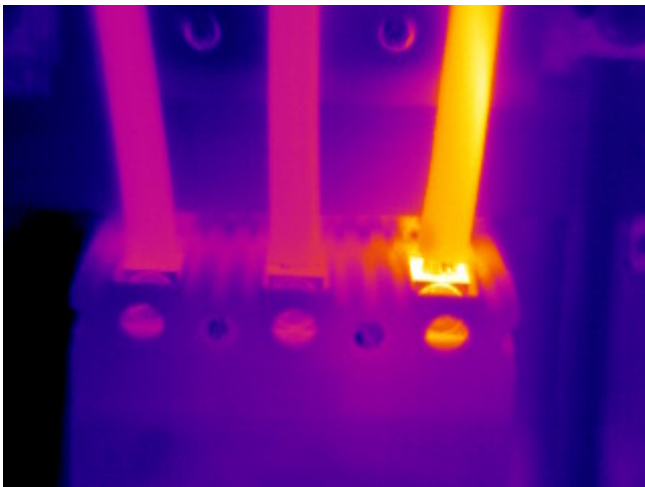
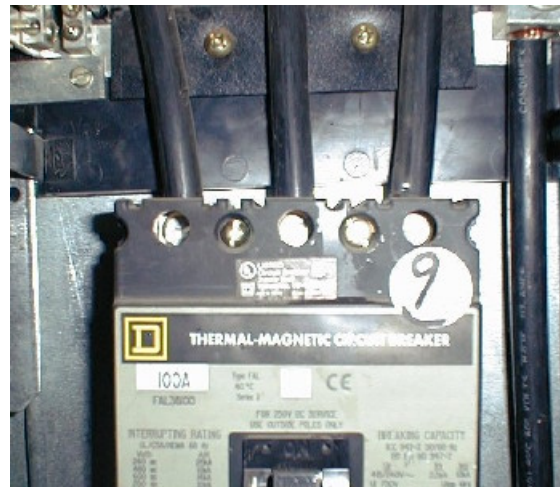
IR Image: IR101.bmp
 Photo: Ph101a.jpg

Pacific Crest Chicago Plant	Asset ID: Barcode: Location: Building A electrical panel
--	---

Problem	Reference	Temperature Difference	Ambient Temperature
A Phase: 88 F	C Phase: 75 F	13 F	68

Problem:
 C Phase line side wire lug connection on circuit breaker - 100 amp

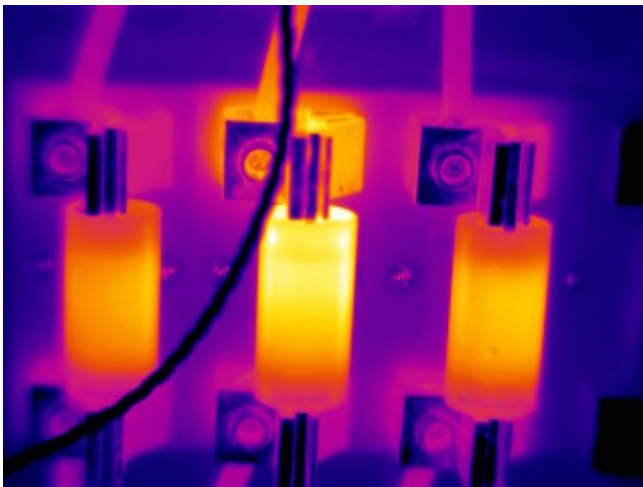
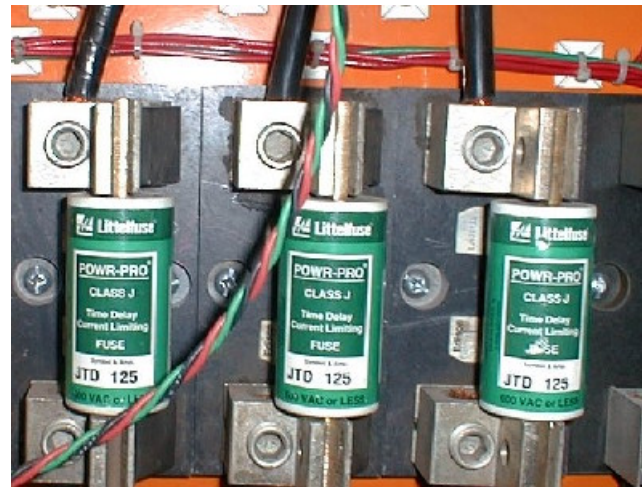
IR Image: IR100.bmp
 Photo: Ph100a.jpg

Asset ID: Barcode:
 Location: Building A
 Electrical Room 777
 Electrical panel 444

Problem	Reference	Temperature Difference	Ambient Temperature
B Phase: 125 F	C Phase: 98 F	27 F	68

B Phase Fuse Clip on Fuse 100A

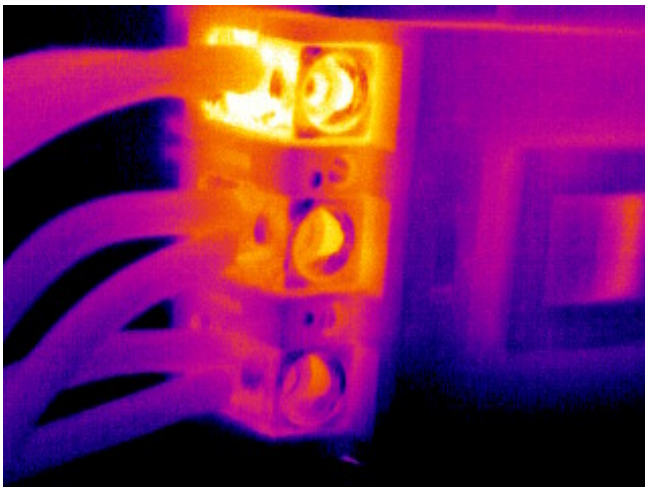
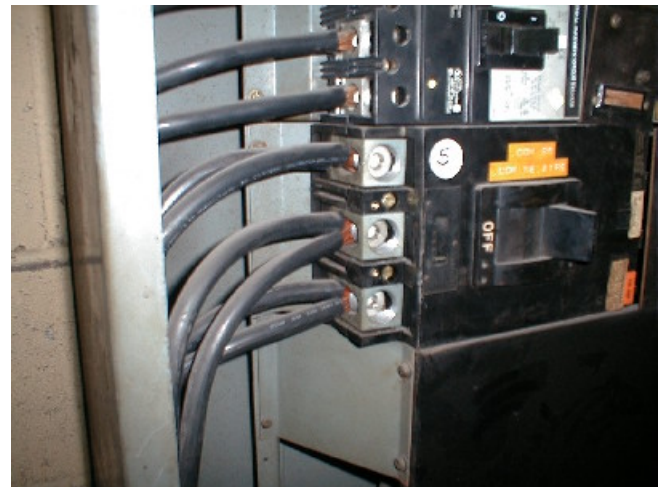
IR Image: B0213-05.bmp
Photo: 12020014.JPG

Pacific Crest Chicago Plant	Asset ID: Barcode: Location: West Tower 3 Floor West Electrical Room WT-3 Electrical Room WT L3-1
--	--

Problem	Reference	Temperature Difference	Ambient Temperature
A Phase: 125 F	B Phase: 98 F	27 F	68

Problem:
A Phase load side wire lug connection on circuit breaker - 100 amp 765675675

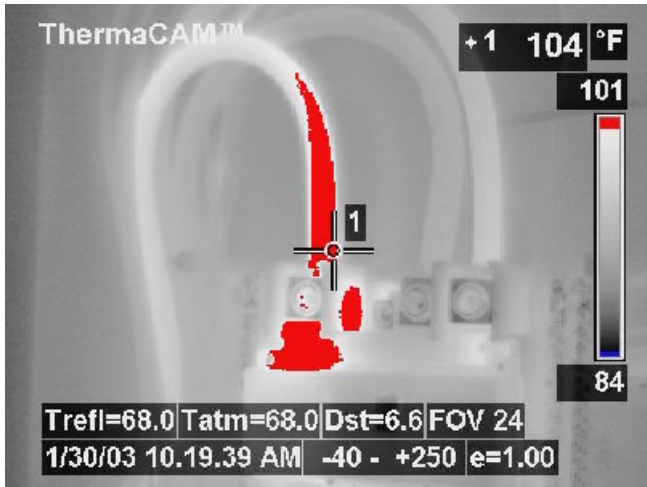
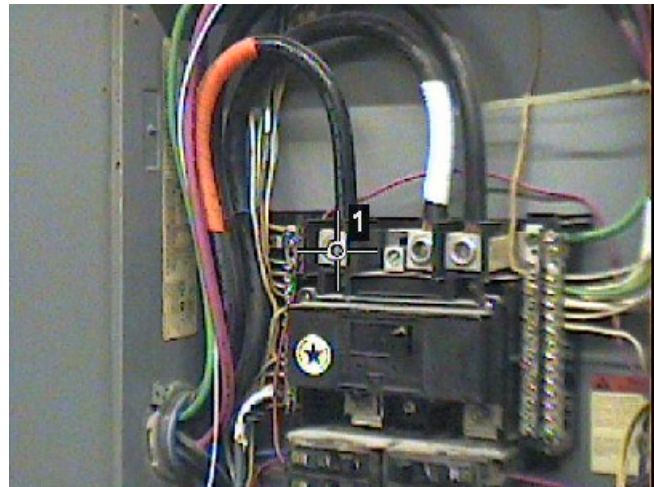
Infrared Filename	Infrared Date	Photo Filename	Photo Date
IR_0036.jpg	4/27/2012	DC_0037.jpg	8/27/2003

Problem	Reference	Temperature Difference
A Phase: 165 F	C Phase: 110 F	55 F

Problem: A Phase line side wire lug connection on circuit breaker - 100 amp

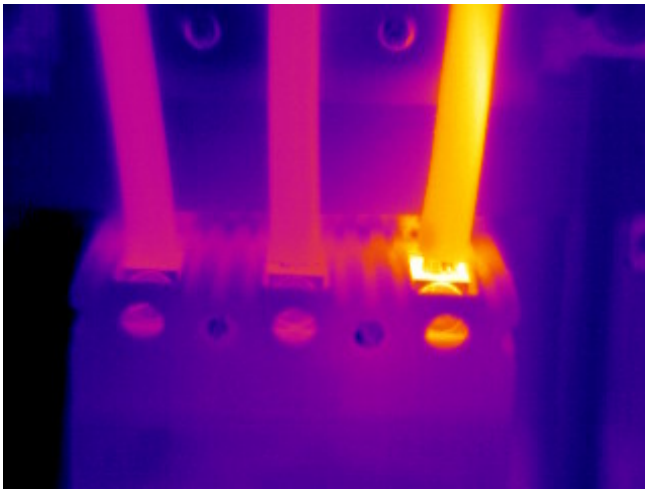
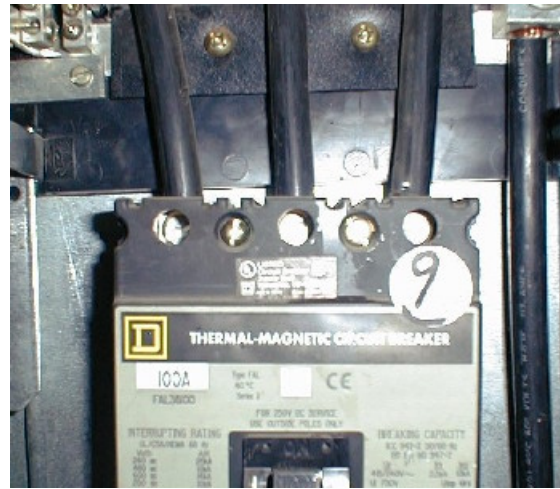
Infrared Filename	Infrared Date	Photo Filename	Photo Date
IR101.bmp	2/13/2001	Ph101a.jpg	4/27/2012

Problem	Reference	Temperature Difference
A Phase: 88 F	C Phase: 75 F	13 F

Problem: C Phase line side wire lug connection on circuit breaker - 100 amp

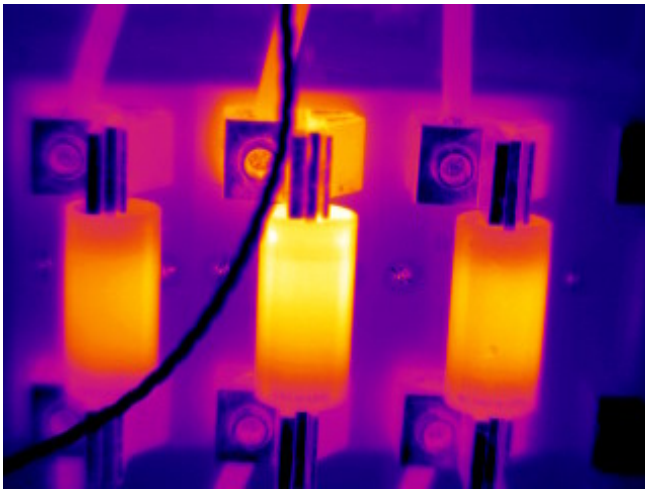
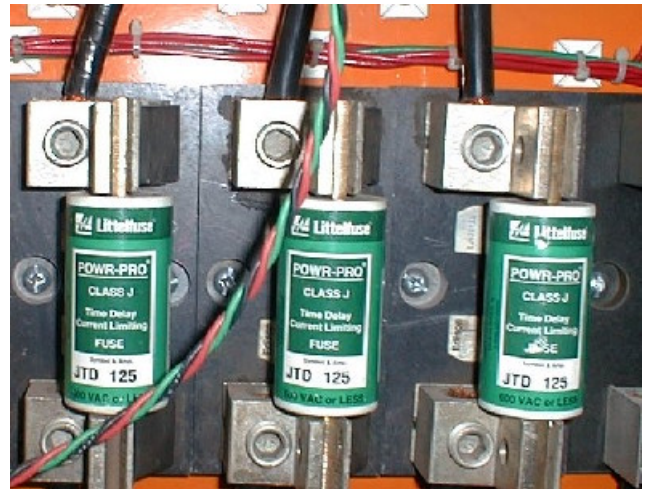
Infrared Filename	Infrared Date	Photo Filename	Photo Date
IR100.bmp	2/21/2001	Ph100a.jpg	4/27/2012

Problem	Reference	Temperature Difference
B Phase: 125 F	C Phase: 98 F	27 F

Problem: B Phase Fuse Clip on Fuse 100A

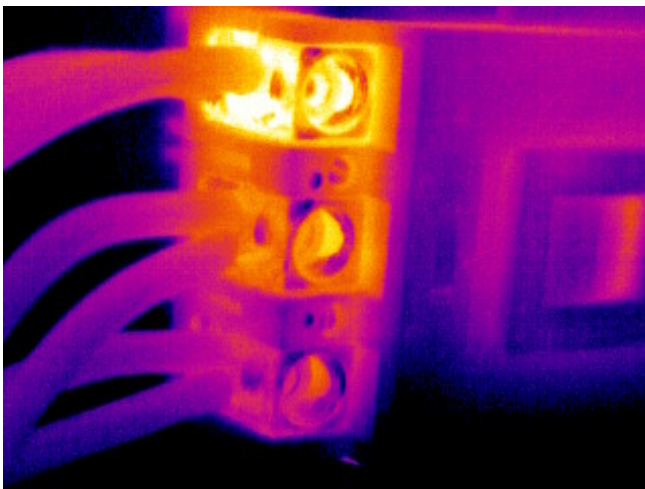
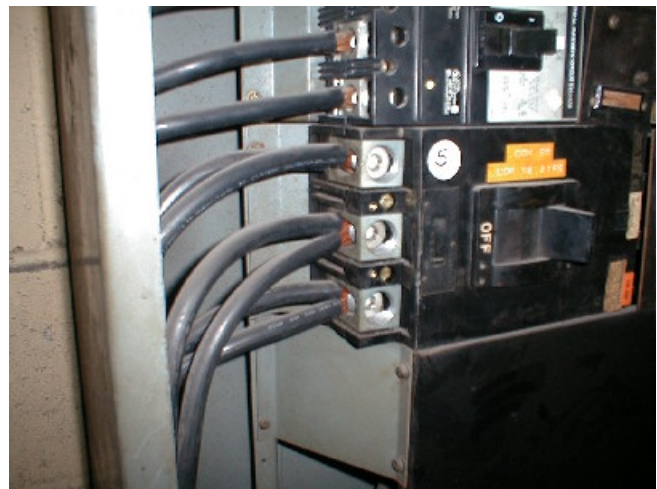
Infrared Filename	Infrared Date	Photo Filename	Photo Date
B0213-05.bmp	2/13/2001	12020014.JPG	12/2/2001

Problem	Reference	Temperature Difference
A Phase: 125 F	B Phase: 98 F	27 F

Problem: A Phase load side wire lug connection on circuit breaker - 100 amp 765675675

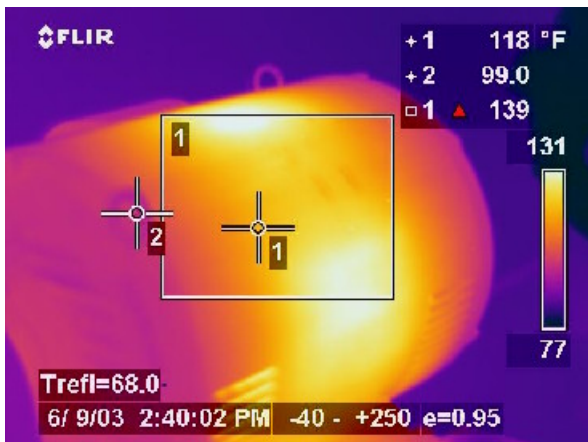
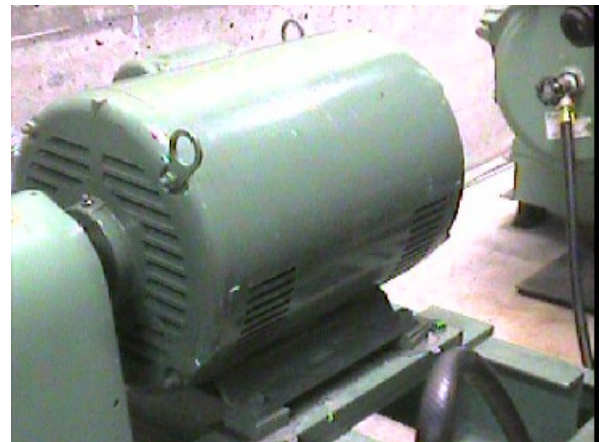
Equipment Location: Main Building \ 1 Floor \
Mechanical Room \ Main Chill
Water Pump Motor

Inspection No	Date Inspected	Test Status	Measured Temp	Threshold Temp	Ambient Temp	Status Note	Customer Notes
1001	2/19/2004	TESTED	118 F	150 F	75 F		
1002	2/19/2004	NTTC	126 F	150 F	77 F		
1003	2/19/2004	TBT	147 F	150 F	77 F		
1004	3/1/2007	TESTED	176 F	150 F	80 F
