On-Roof Infrared Thermographic Survey of Roof Moisture

Widget Company
Your Town, USA

March 1, 2016

**Re: On-Roof Infrared Survey of Roof Moisture
United Widget in Your Town, USA**

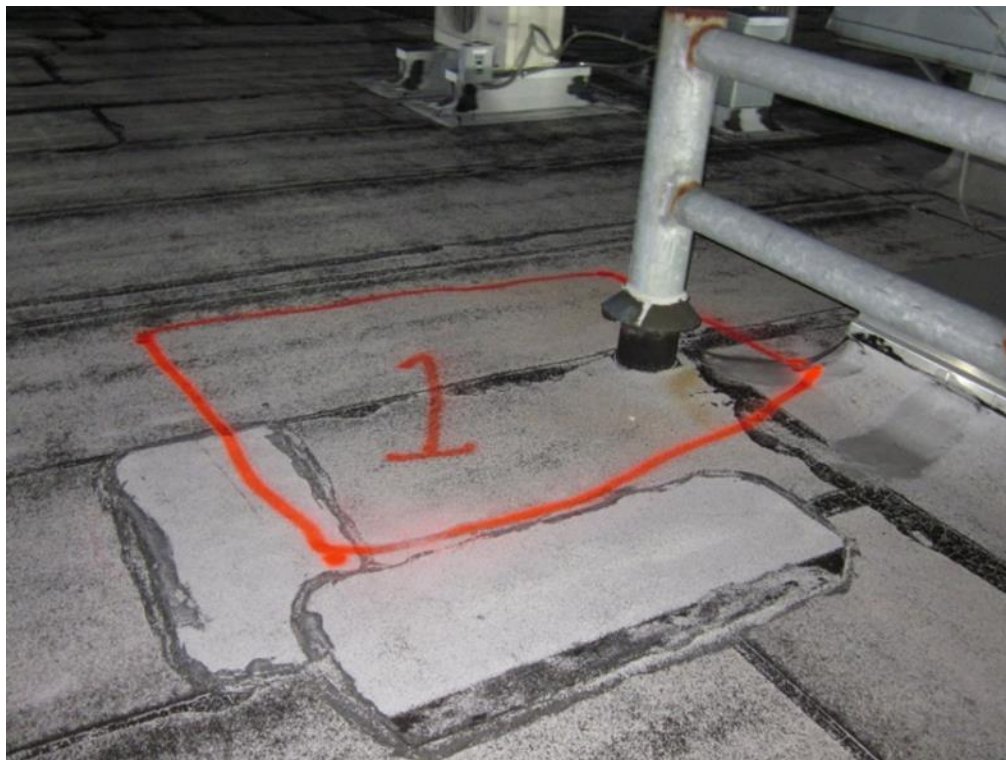
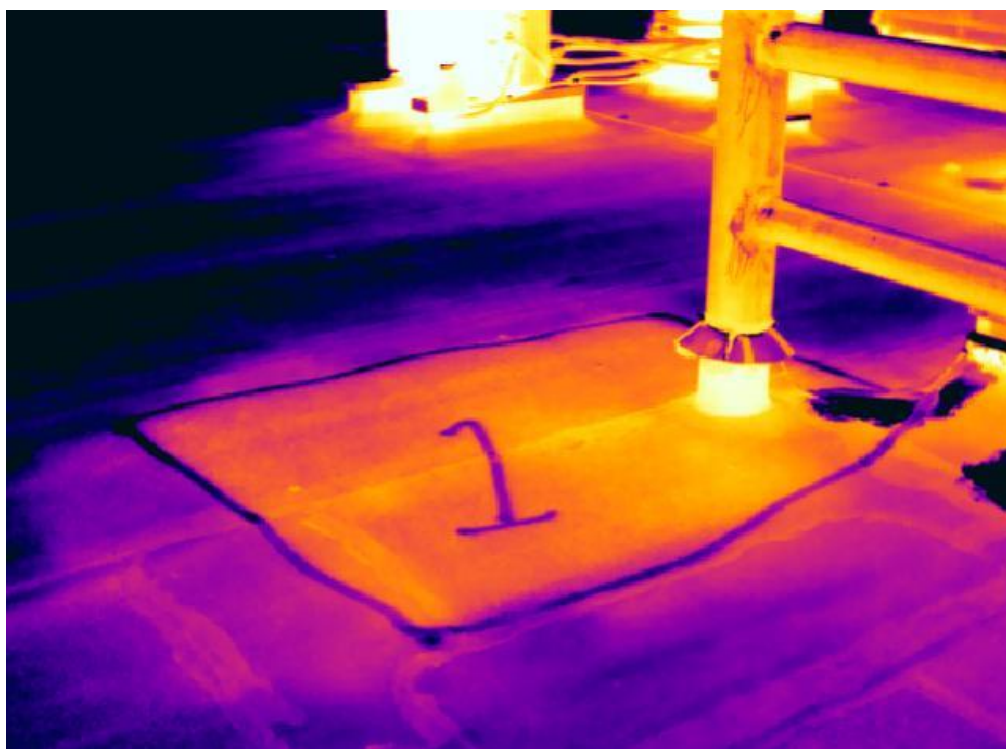
Thermographic Report # 1

Notes: Areas of suspect subsurface moisture are marked directly on the roof.

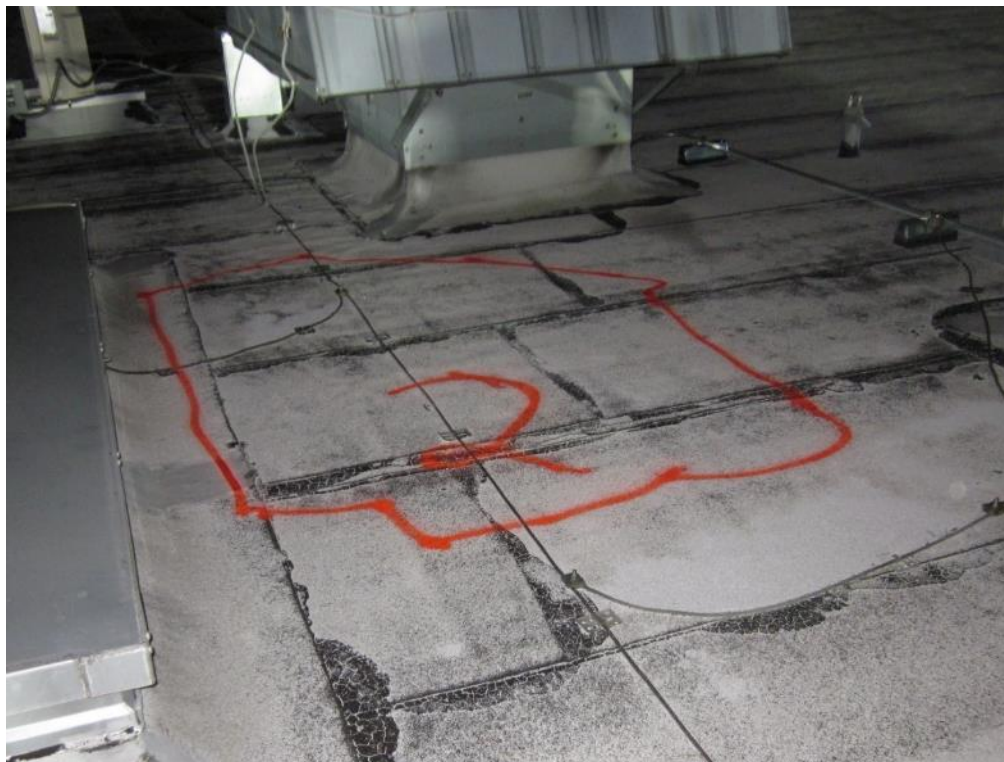
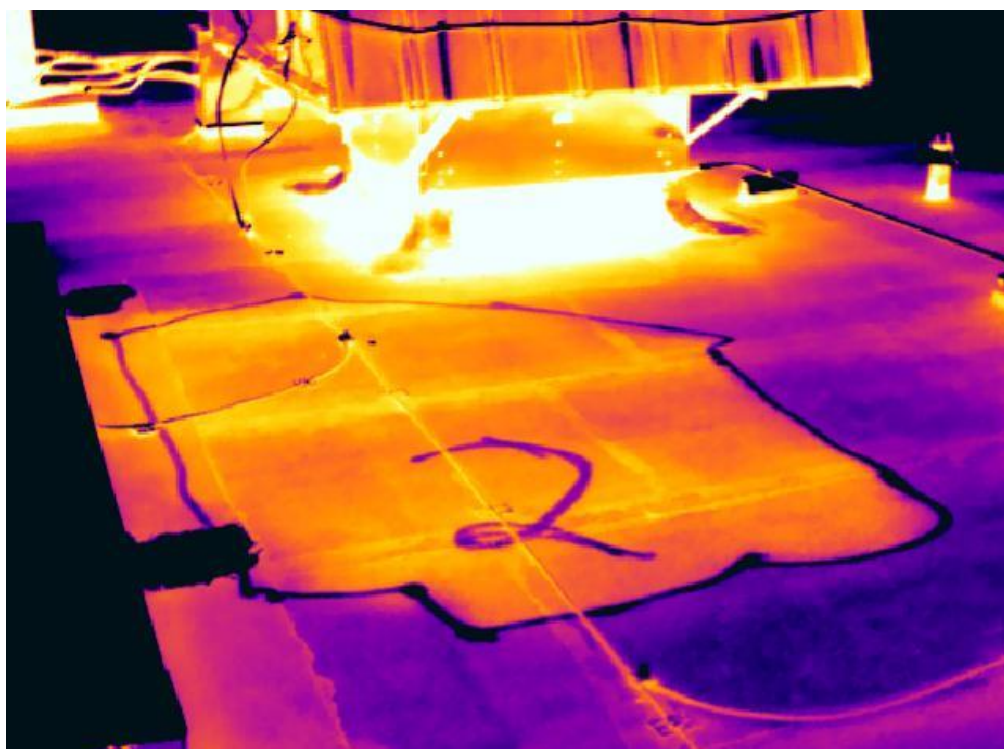
Thermographic Report # 2

Notes: Areas of suspect subsurface moisture are marked directly on the roof.

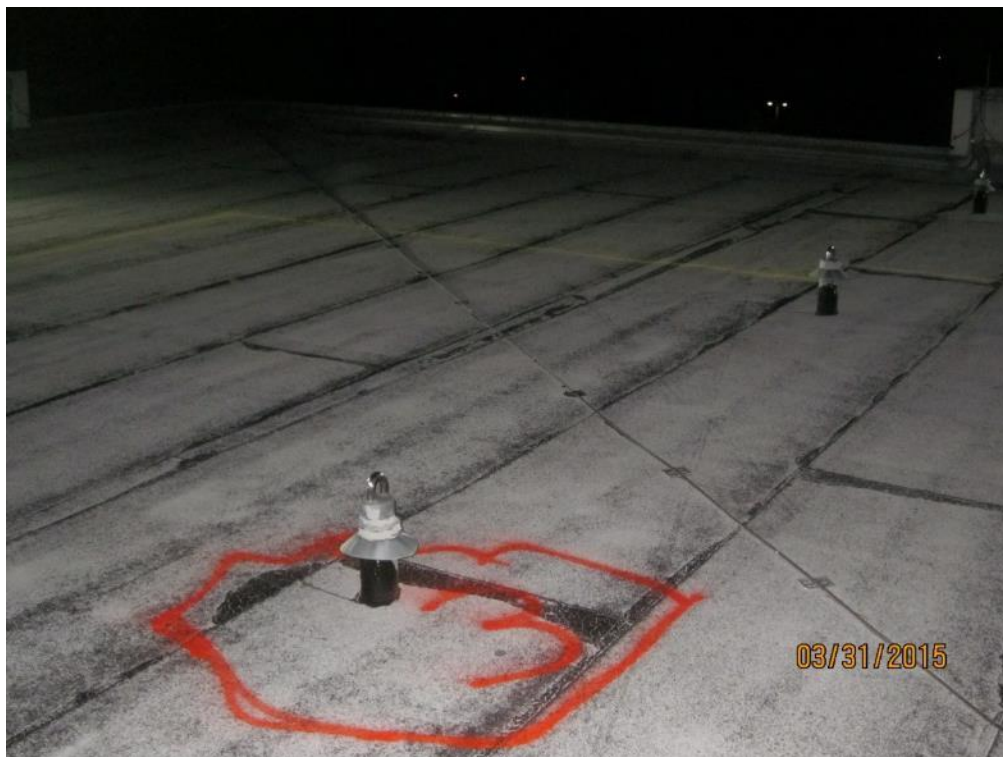
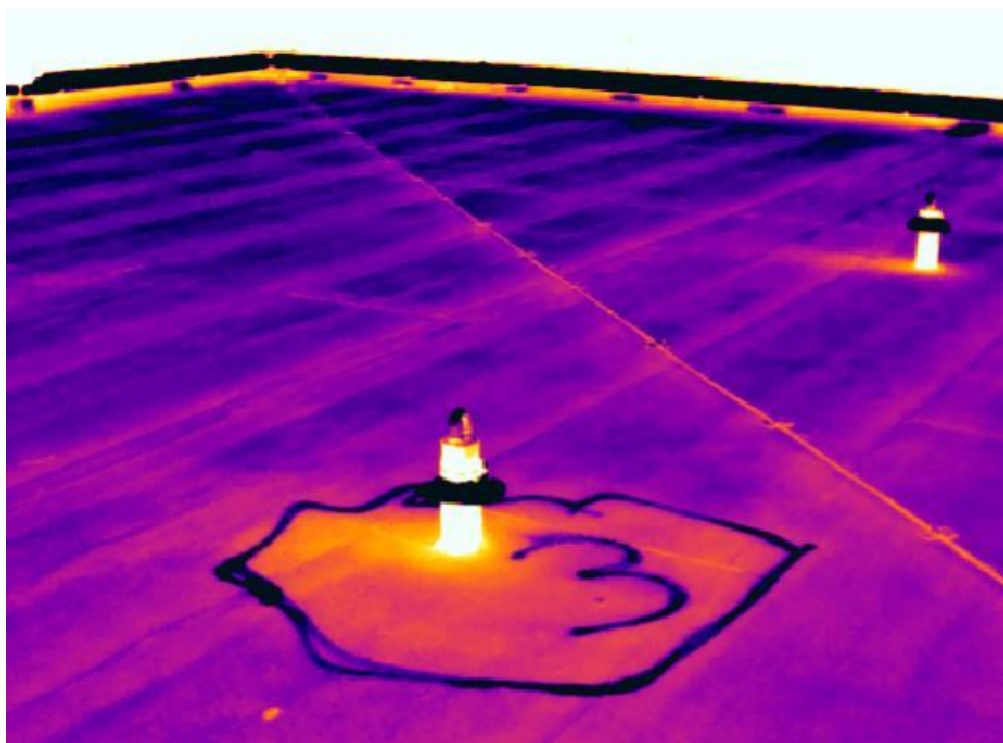
Thermographic Report # 3

Notes: Areas of suspect subsurface moisture are marked directly on the roof.

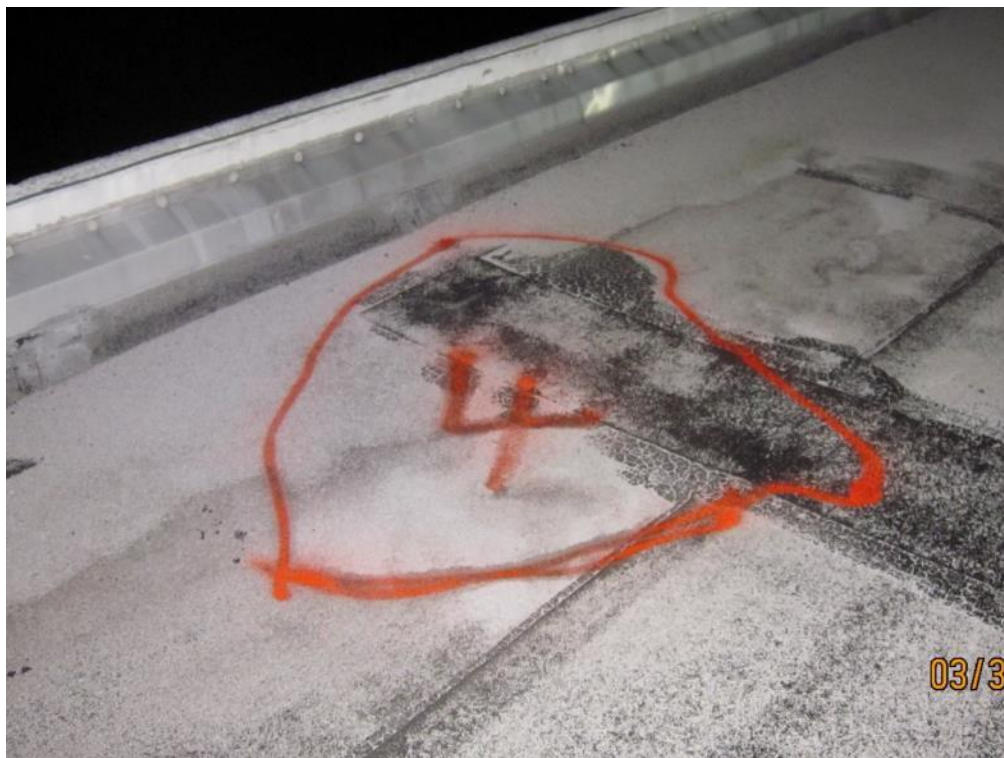
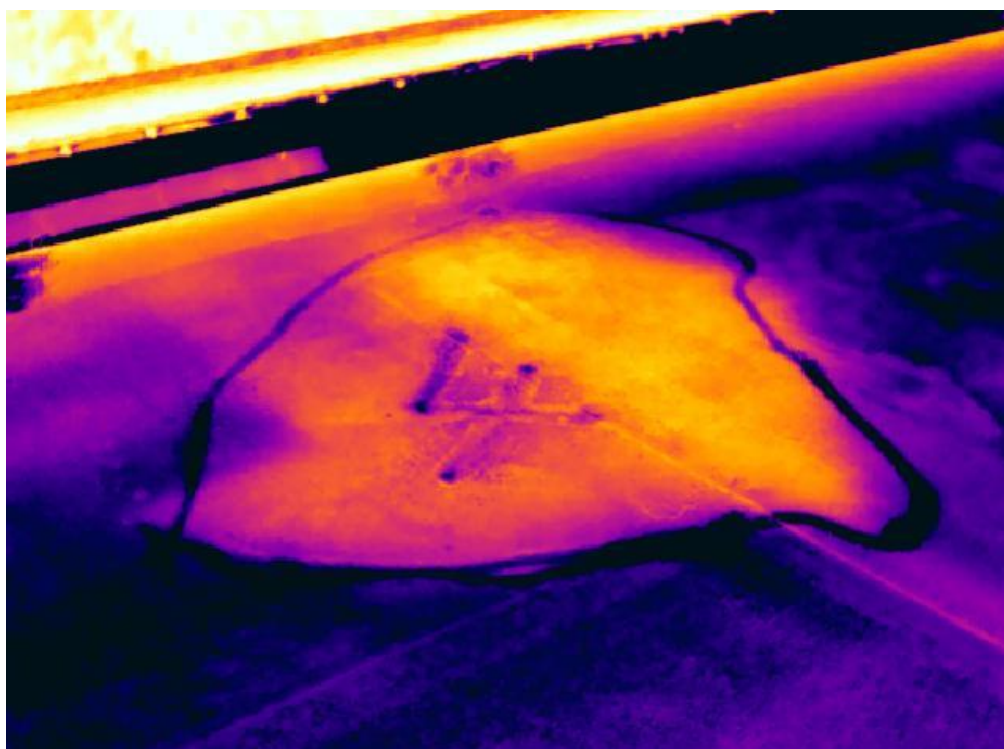
Thermographic Report # 4

Notes: Areas of suspect subsurface moisture are marked directly on the roof.

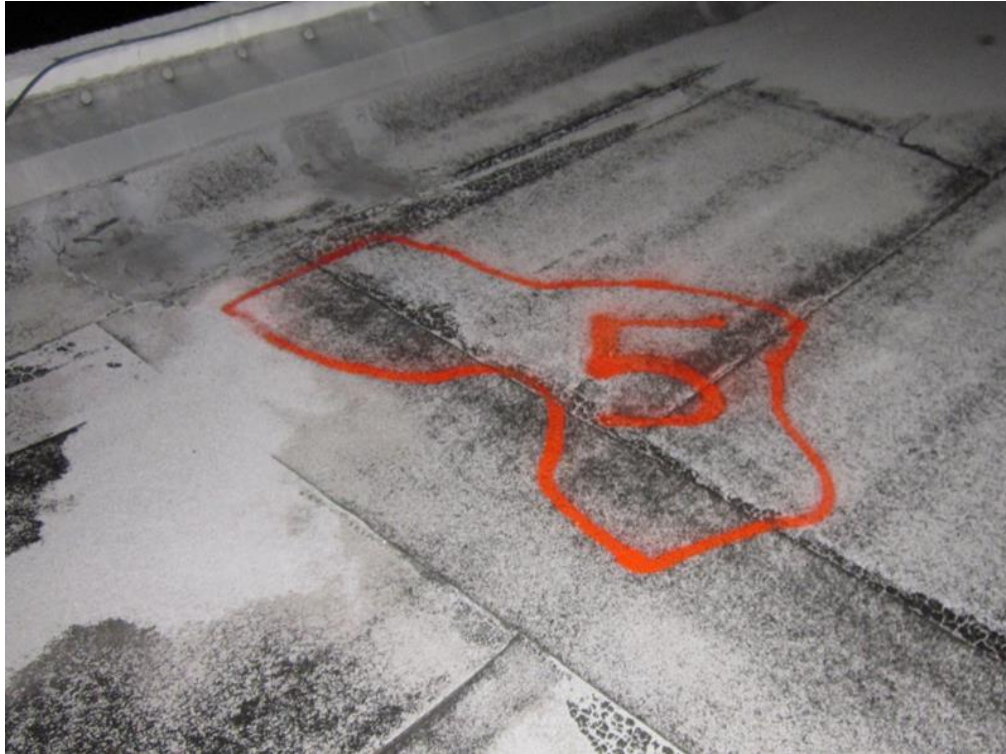
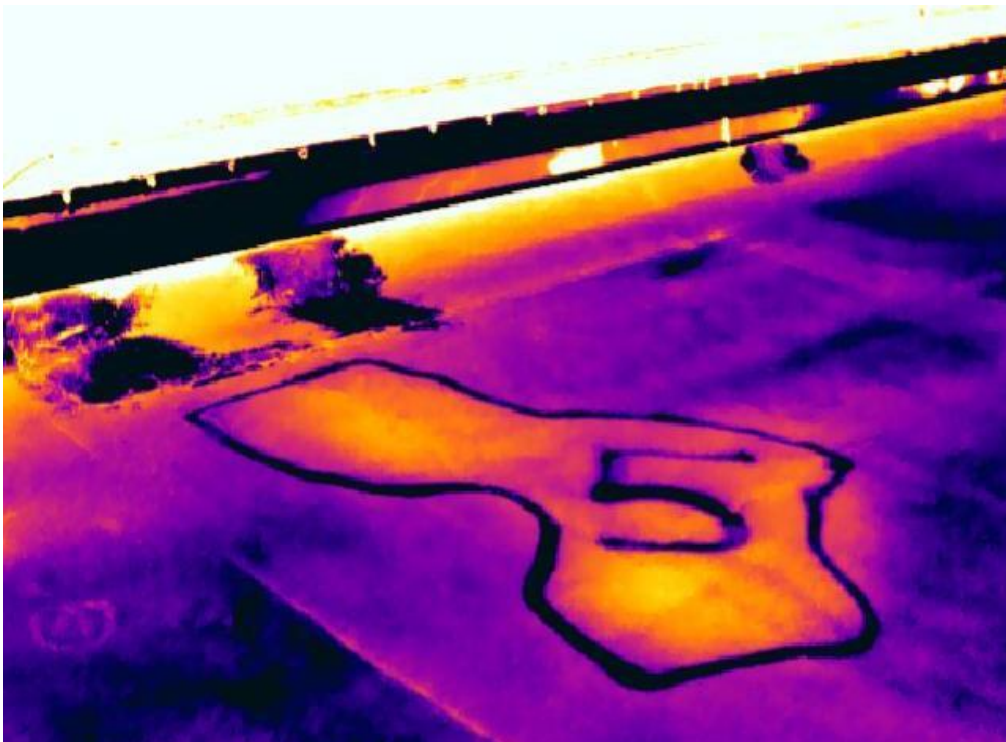
Thermographic Report # 5

Notes: Areas of suspect subsurface moisture are marked directly on the roof.

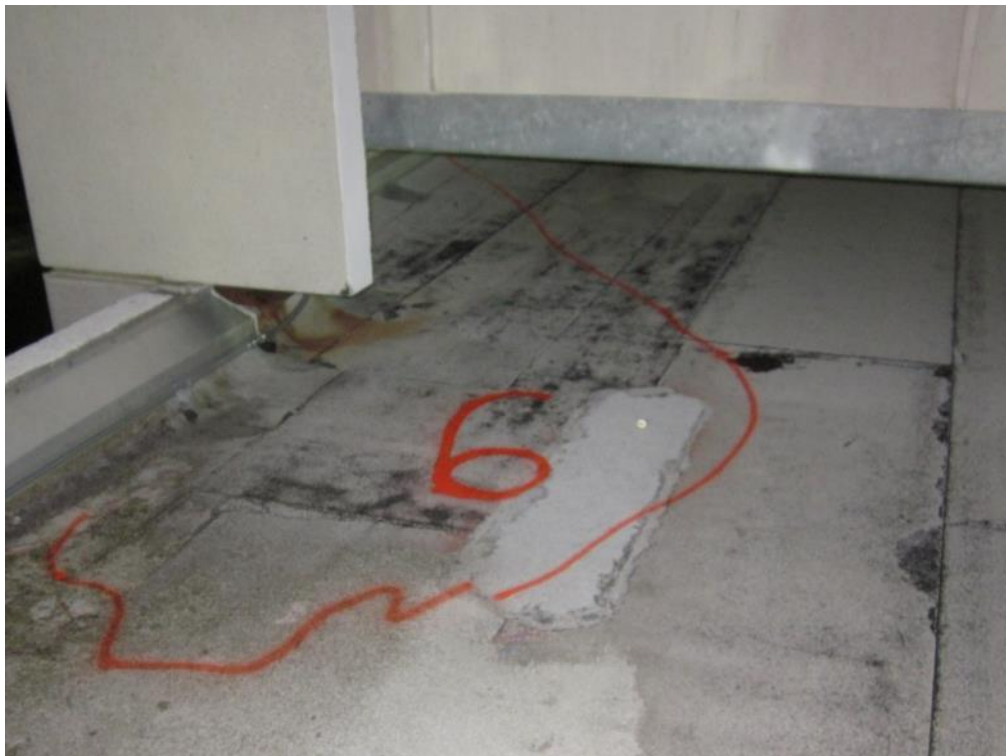
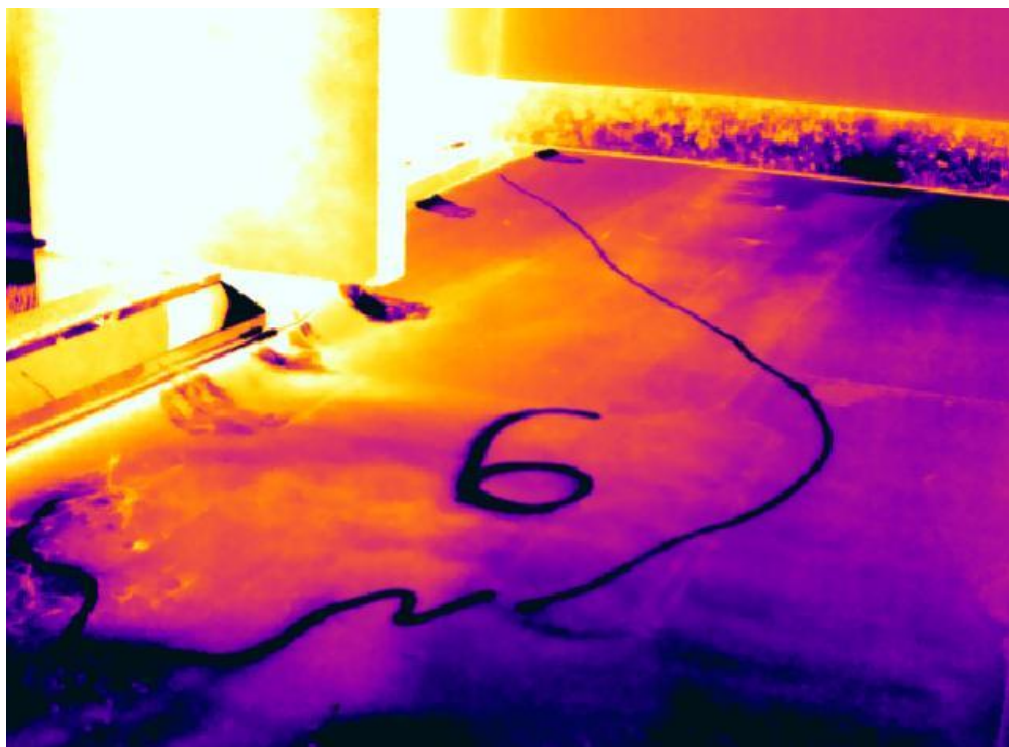
Thermographic Report # 6

Notes: Areas of suspect subsurface moisture are marked directly on the roof.

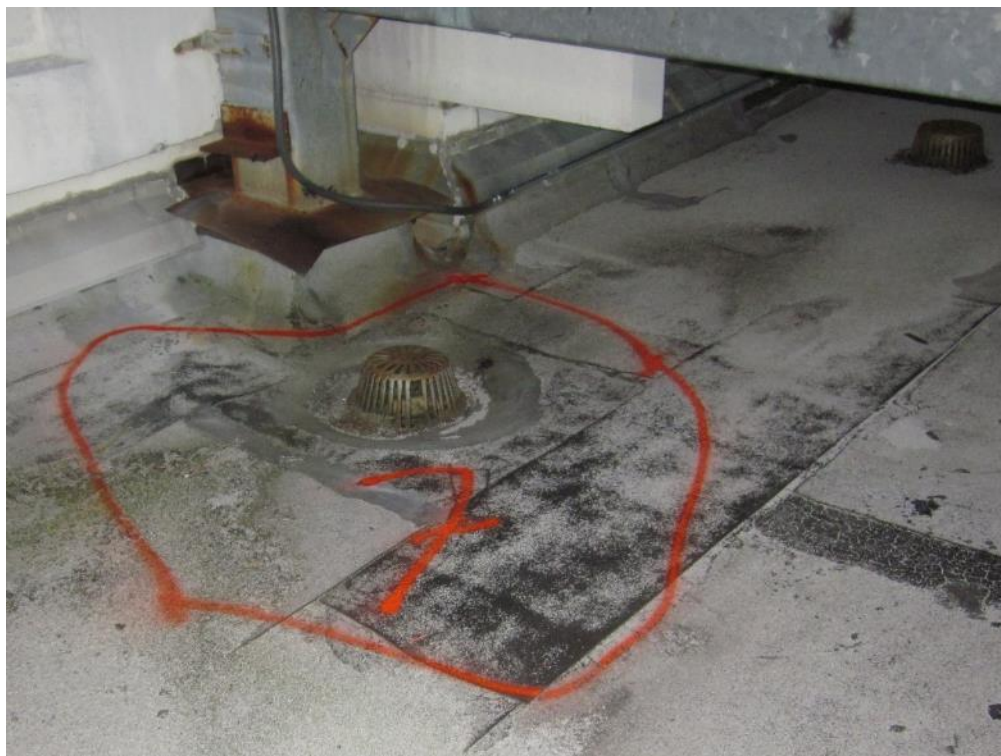
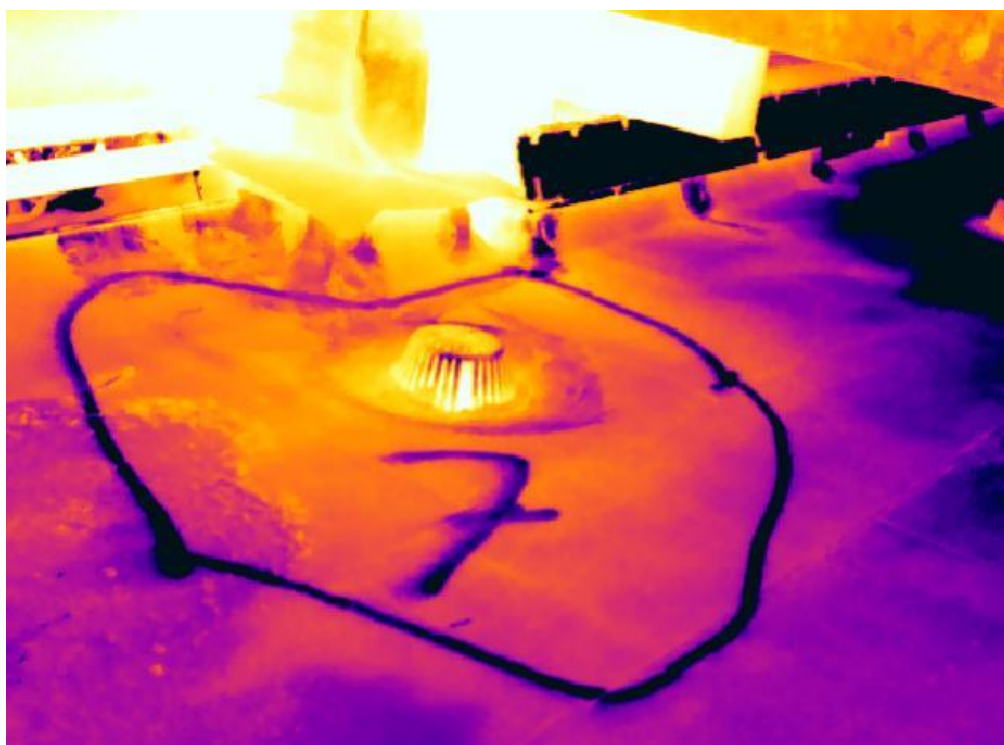
Thermographic Report # 7

Notes: Areas of suspect subsurface moisture are marked directly on the roof.

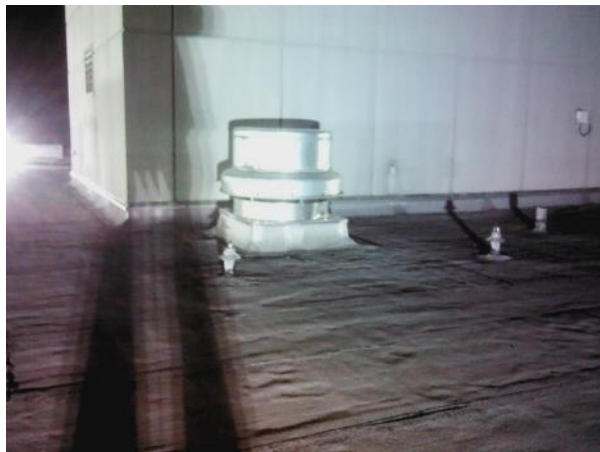
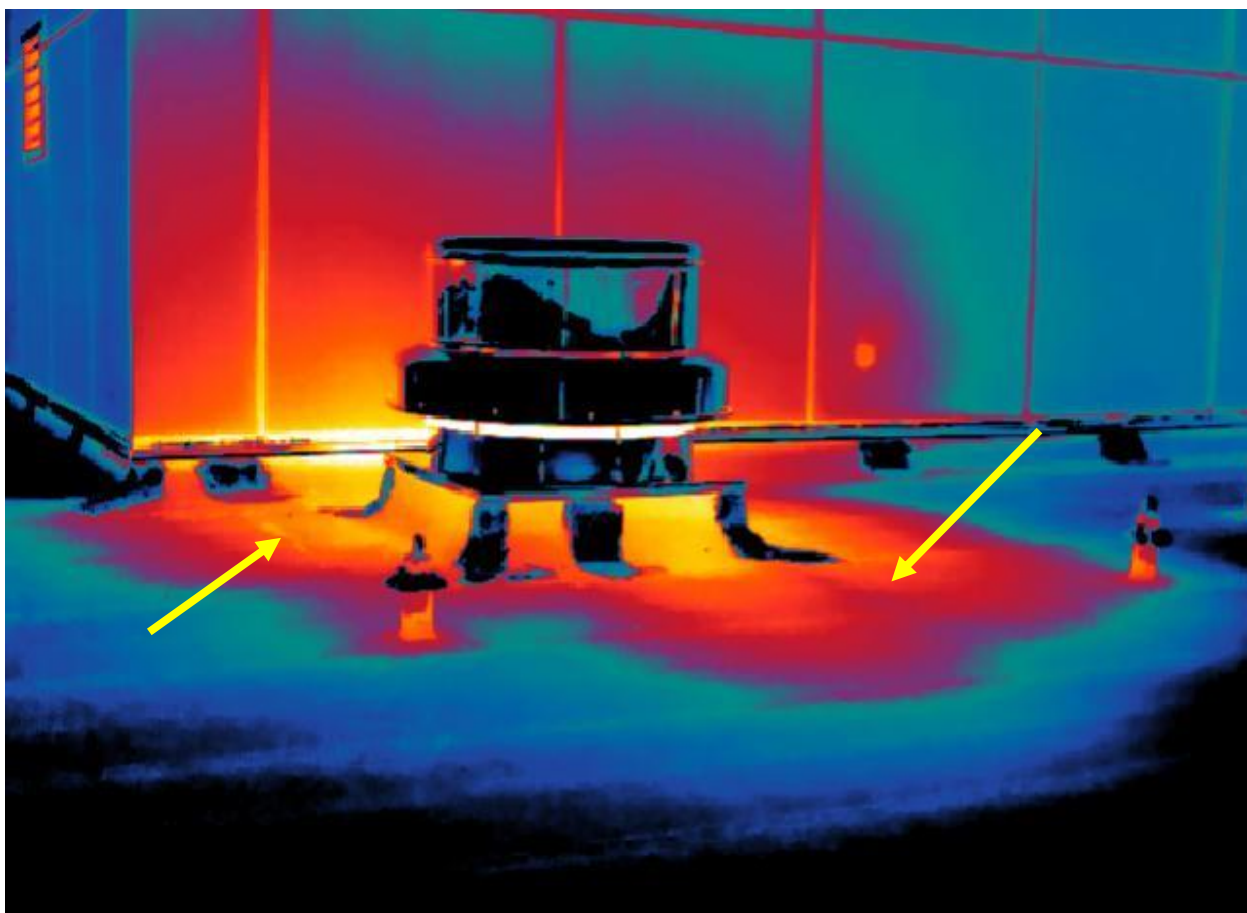
Thermographic Report # A

Notes: Check area, as heat from the fan masked the IR imagery.

Heat from the fan
blowing hot air on
the roof as indicated.
